## EXCAVATIONS AT HÂJÎÂBÂD, 1977 FIRST PRELIMINARY REPORT

M. AZARNOUSH

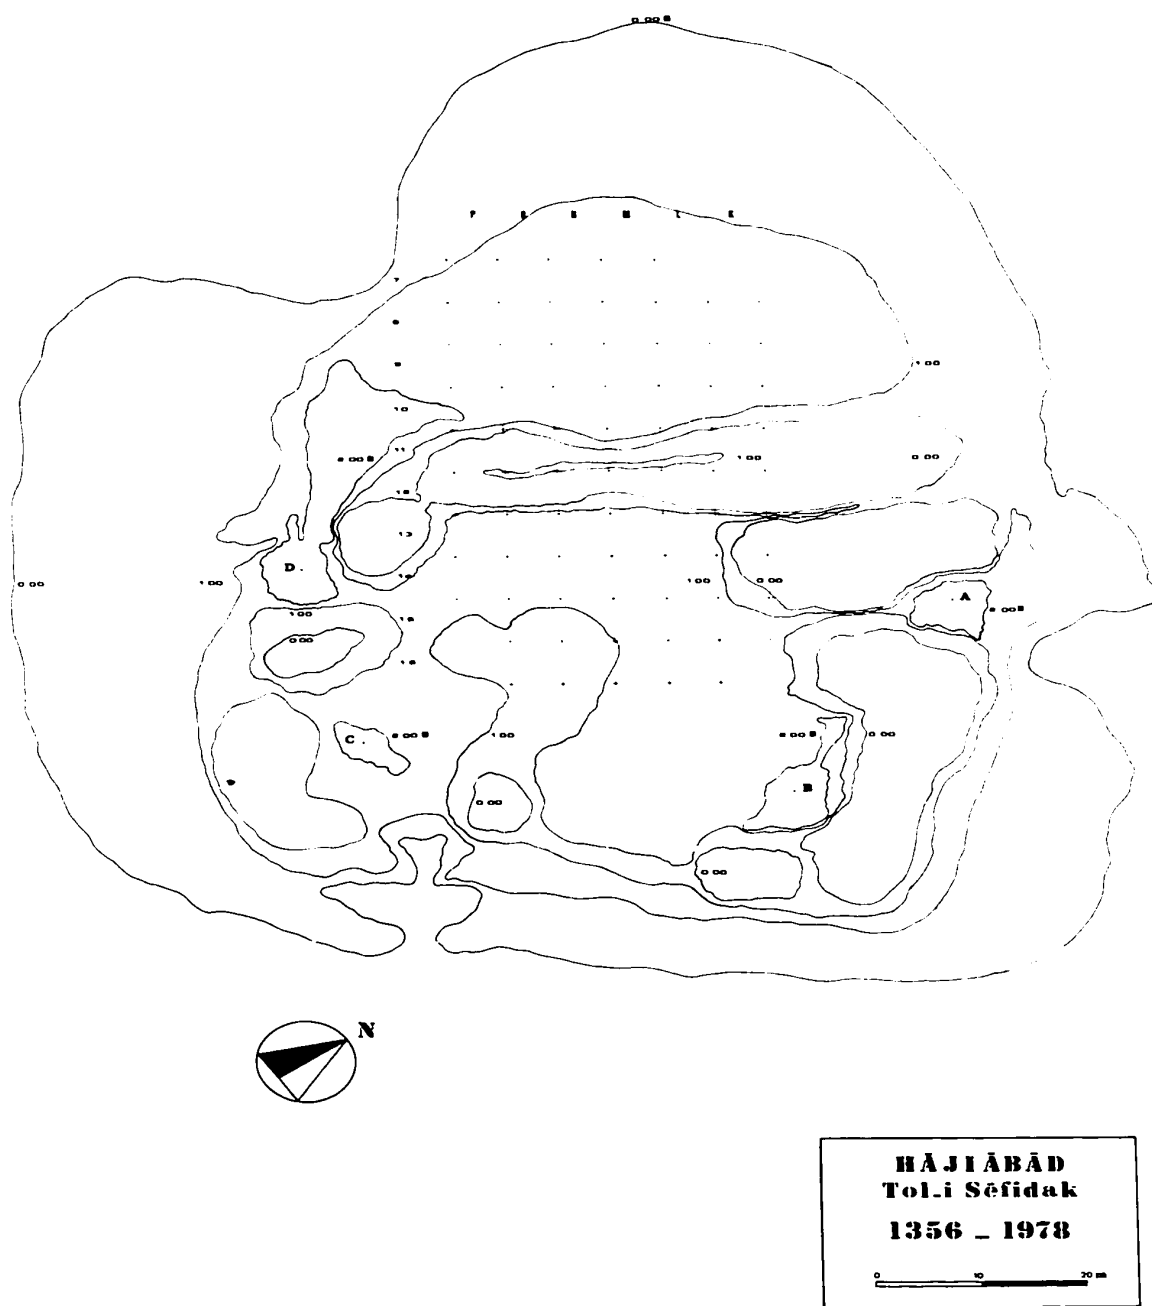
Fig. 3. Hājiābād — Tull-i Sifīdak. Contour Map (by M. Azarnoush).

The site is severely damaged, with nearly 60 per cent of the mound removed. The destruction extends so deeply, that in some areas even the foundations of the structure are no longer traceable (Fig. 3, Pl. II).
